Belen Apartments Affordable Housing Renovation, Belen, NM

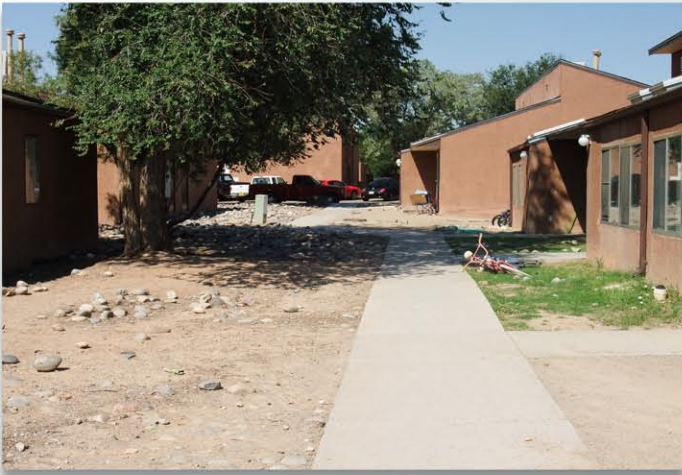
images from top to bottom:
Existing Conditions
Rendering showing upgrades (Autotroph)
Existing, overgrown stormwater pond

The Belen Apartments is a 39-unit multi-family affordable housing development located in Belen, NM. The subsidized family project is undergoing a renovation to improve energy efficiency, water conservation, stormwater management and general landscaping. The project has qualified for the Enterprise Green Communities Criteria for Moderate Rehabilitations, thus meeting a housing industry standard for green renovations. Natural Systems International (NSI) worked with Autotroph architects and the client to provide the design of the new stormwater management plan that improves drainage, incorporates 'rain gardens' to support native plantings, and utilizes a constructed wetland to treat the site's stormwater runoff.
